Addendum to H-58-11-AMAM-13 FUEL SYSTEM

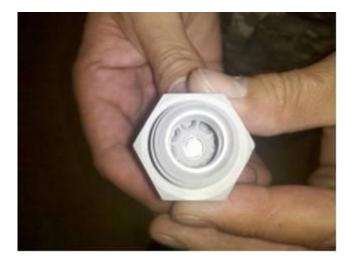
Inspect uninstalled Fuel Check Valve, PN 406-360-600-101, opening for presence of internal valve. **WARNING**: Do Not Disassemble Valve. Visually check to ensure internal valve is secure and does not move in the housing. Inspect for damaged threads, Inspect housing for cracks, corrosion, or obvious defects. If damage is found, no repair is authorized. Dispose of in accordance with established procedures.

Figure 1: Unserviceable

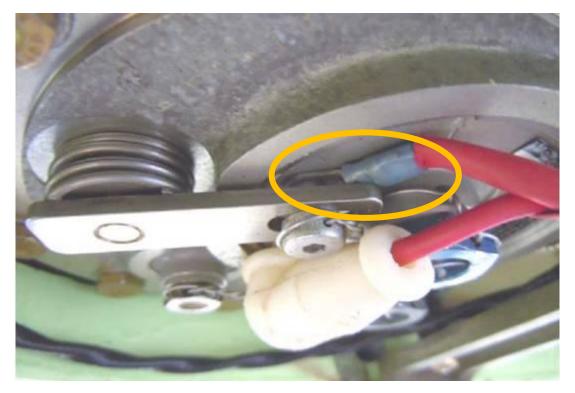
Figure 3: Ground Terminal incorrectly secured under Fuel Inlet Shutoff Valve Arm.
